| | <h1>Release Notes</h1> | Lantronix AVL Products |
| | Firmware version: <a href="#">avl_4.7.0_rc6</a> | Document revision: 4.7.0 |

**VERSION:** [avl\\_4.7.0\\_RC6](#)  
 BIOS version: [3.0.4](#)  
 Official release date: [03/09/2026 \(D/M/Y\)](#)  
 List of firmware files: [avl\\_4.7.0\\_rc6\\_20260901.signed.frp](#)  
[avl\\_4.7.0\\_rc6\\_Zb8029018.signed.zip](#)  
[avl\\_4.7.0\\_rc6\\_20260901.signed.txt](#)  
 Hardware compatibility: This firmware applies to the following LANTRONIX products with Cortex processor:

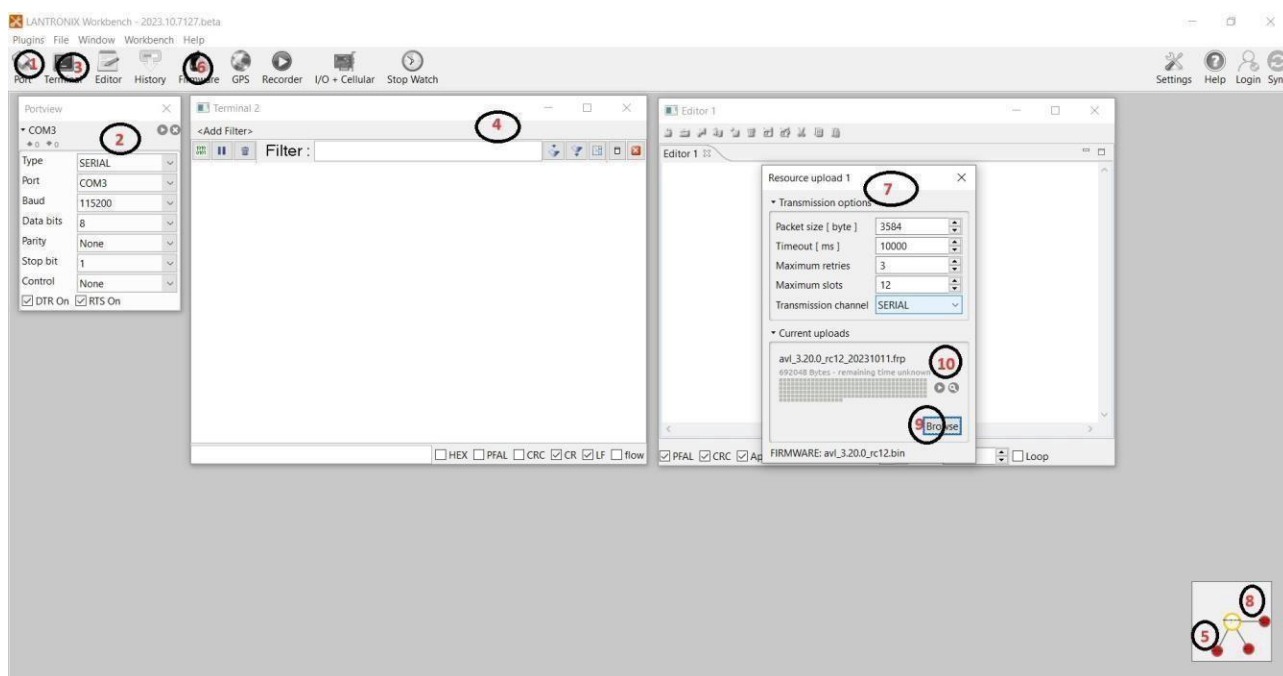
(b) Begin the firmware update process (refer to the fig. above).

1. Connect the AVL device to your PC either directly using the programming cable or the corresponding evaluation board.
2. Do **NOT** update the firmware version 4.x.x on FOX4 devices with an older processor. The firmware version 4.x.x is **ONLY** for FOX4 with the **CORTEX (CT)** processor. Please verify the hardware revision from the table "**Hardware compatibility**" above and make sure you are upgrading a FOX4 device with CORTEX processor. LANTRONIX takes no liability and no responsibility for any cases, firmware versions have been flashed wrongly nor will LANTRONIX cover any costs associated with this happening.
