| | <h1>Release Notes</h1> | | Lantronix AVL Products |
| | Firmware version: <a href="#">avl_5.2.0_rc3</a> | | Document revision: 5.2.0 |

## Lantronix AVL FIRMWARE RELEASE

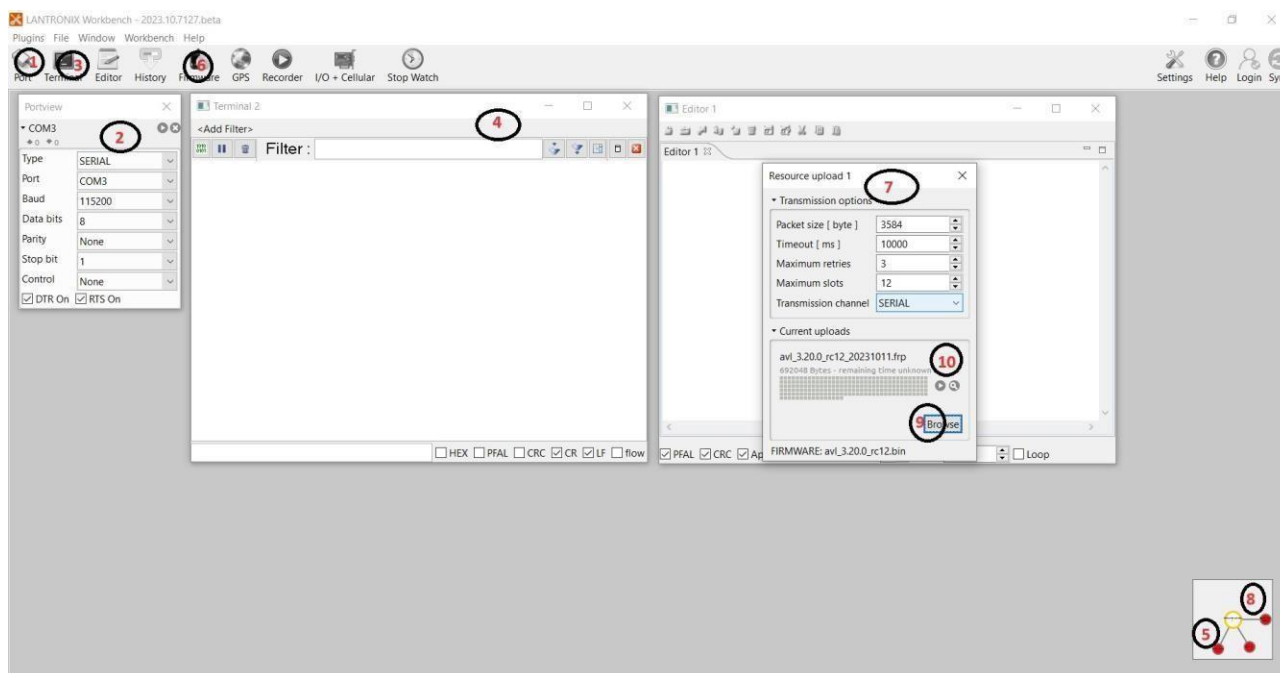
(b) Begin the firmware update process (refer to the fig. above).

1. Connect the AVL device to your PC either directly using the programming cable or the corresponding evaluation board.
2. Do **NOT** update the firmware version 4.x.x on FOX5 devices with an older processor. The firmware version 5.x.x is **ONLY** for FOX5 with the **CORTEX (CT)** processor. Please verify the hardware revision from the table "**Hardware compatibility**" above and make sure you are upgrading a FOX5 device with CORTEX processor. LANTRONIX takes no liability and no responsibility for any cases, firmware versions have been flashed wrongly nor will LANTRONIX cover any costs associated with this happening.

(a) Download the firmware file and Workbench software needed from the following hyperlinks.

1. <https://www.lantronix.com/products/workbench/#tab-docs-downloads>
2. <https://www.lantronix.com/products/FOX5-series/#tab-docs-downloads>
3. Download " [avl\\_5.2.0\\_rc3.signed.frp](#)" and extract the file you downloaded into a temporary folder on your PC.
4. Run the "workbench" software. If this software is still not installed on your PC, download it first and start the installation.
