**Software Release Note**

**RELEASE DATE:** 13-May-2011  
**FIRMWARE VERSION:** V1.29  
**KERNEL VERION:** V3.50

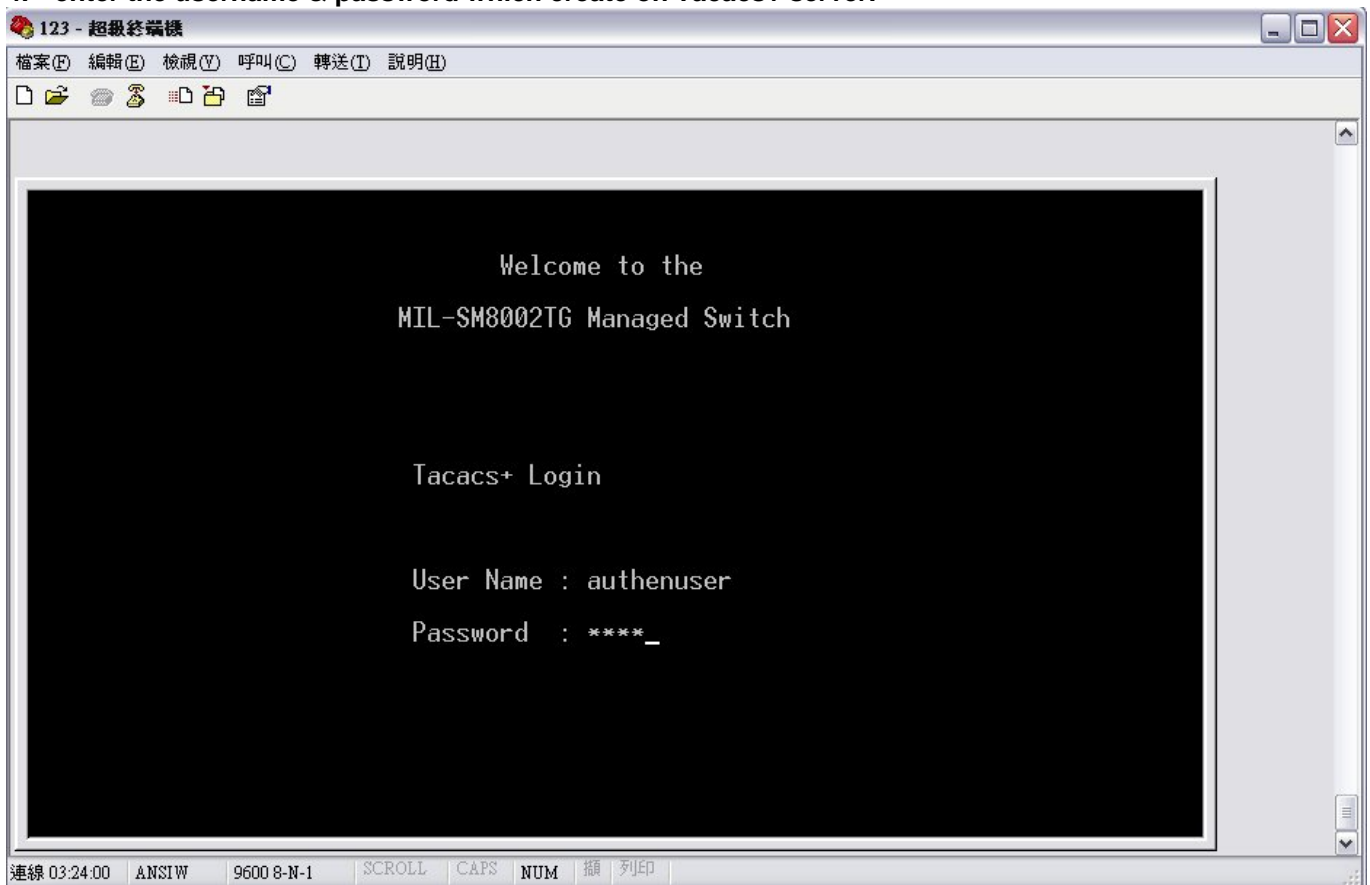
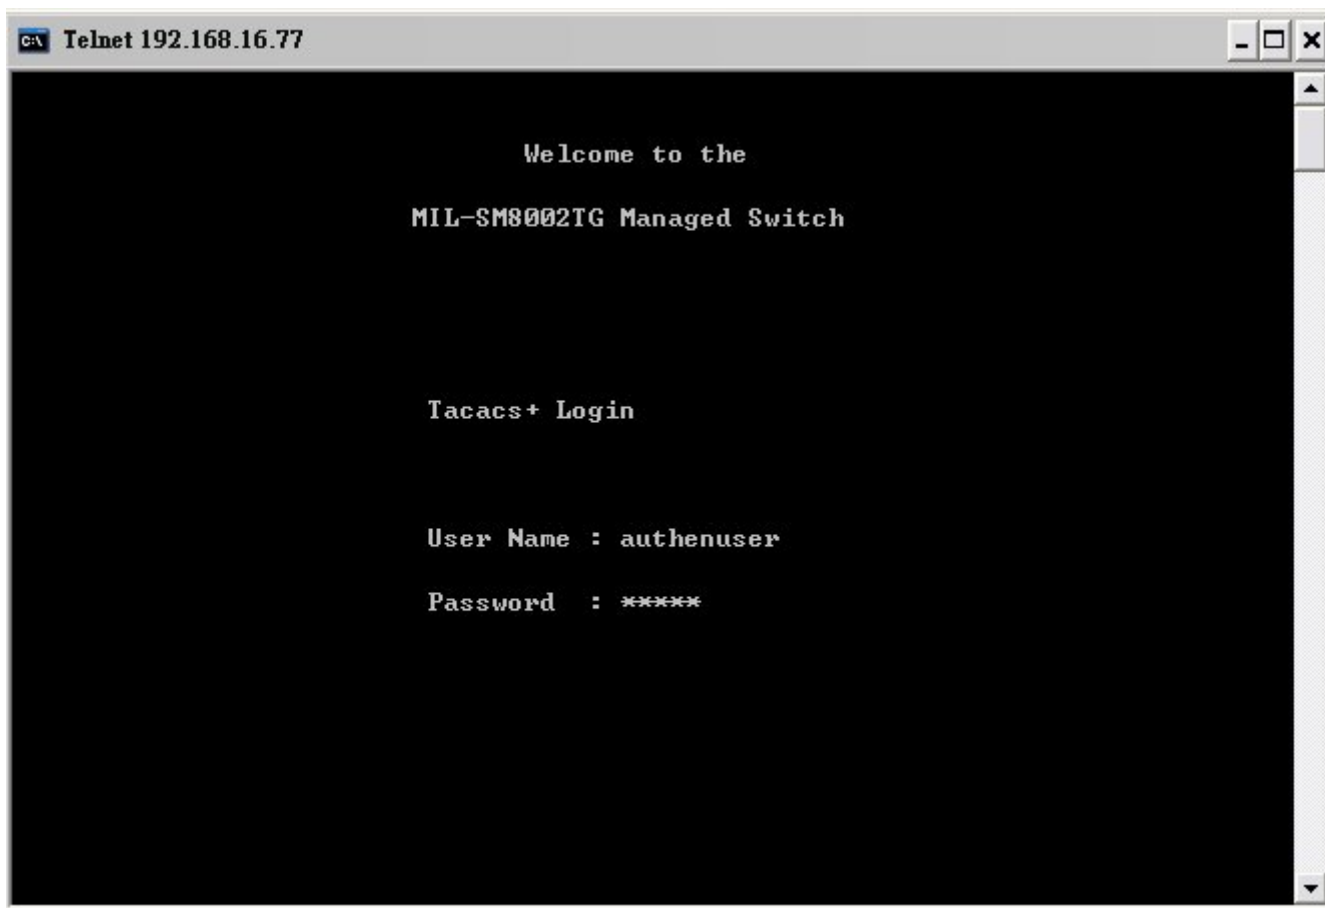
1. Enable Tacacs+ function.
2. Configure Server IP and encrypt key
3. Select encrypt connection
4. enter the username & password which create on Tacacs+ server.
